Cracking Down on PV Module Design: Results from Independent Testing

The Mechanical Stress Sequence in PVEL's PV Module Product Qualification Program

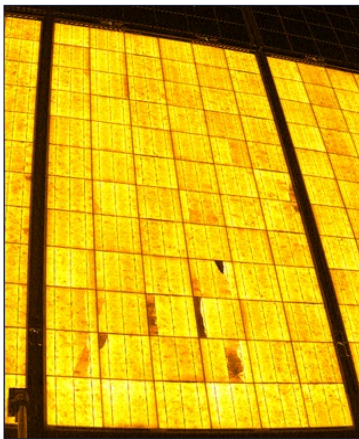
The PV module above was damaged by a tornado leading to cell cracks and inactive/dark areas. This EL image was taken by PVEL in the field.

Cell cracks appear as dark, discolored, broken lines or areas in electroluminescence (EL) images. The module could produce less energy if these cracks restrict the flow of current through the cell.

A local hotspot may eventually form in the damaged area of the cell, which can accelerate backsheet degradation and delamination, eventually increasing the risk that ground and arc faults will occur.

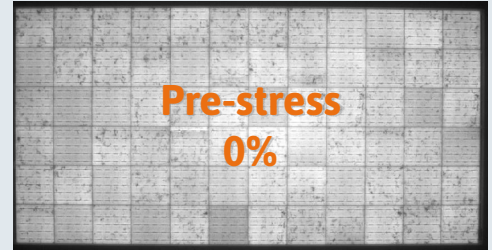
1

Step 1: Factory Witness and Intake

- As samples are manufactured, BOMs are witnessed in production from the opening of raw materials through every step of the production until they are palletized with tamper-proof tape and received at PVEL's labs.
- Once received, modules undergo flash testing and EL imaging to capture power output and physical condition before they are subjected to the test sequence.

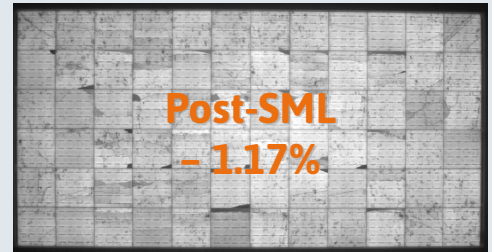
2

Step 2: Static Mechanical Load (SML)

- Modules are mounted on two rails, secured to the module at typical ground mount clamping locations.
- Modules are then subjected to three cycles of one hour of downforce and one hour of upforce pressure of 2400 Pa, which is comparable to hurricane-force winds and heavy snow loads.
- This step creates cell cracks in susceptible modules.

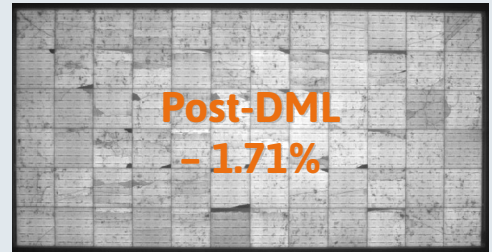
3

Step 3: Dynamic Mechanical Load (DML)

- The mounted modules are subjected to 1000 cycles of alternating positive and negative loading at 1000 Pa, which simulates variable windspeeds and wind shear.
- This step articulates existing cracks, creating inactive areas or increased series resistance.

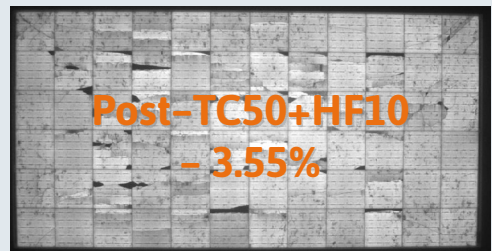
4

Step 4: Environmental Stress

- Modules are placed in environmental chambers and subjected to 50 thermal cycles from +85°C to -40°C, with current injected into the module as the temperature rises.
- Modules are then subjected to 10 cycles of humidity freeze - high heat and high humidity, followed by a rapid drop to freezing temperatures.
- This step simulates an acceleration of natural, daily temperature changes and other environmental conditions that cause cracks to propagate through cell metallization.

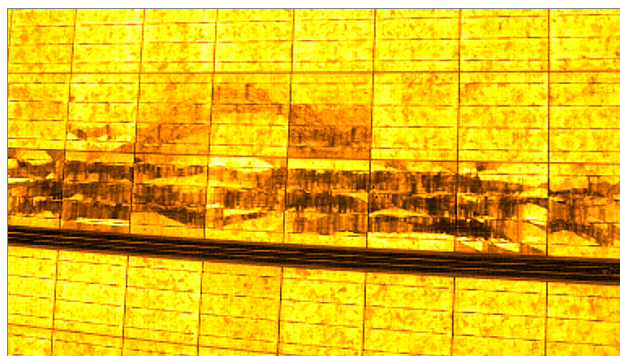
The magnified EL image above shows multiple branching cracks in a fielded PV module.

Different shapes, sizes and types of cracks affect PV modules in different ways, although in PVEL’s lab and field testing experience, branching cracks (also known as dendritic cracks) that spread through cells as modules age in the field are usually the most destructive. As shown in the PVEL test results that follow, BOMs can experience significant cell cracking when they are installed according to the structurally-optimal mounting method employed for MSS testing. **In PVEL’s experience, the use of alternative mounting configurations – which are common in the field – can subject modules to additional stresses and thereby increase the potential for cracks to occur.**

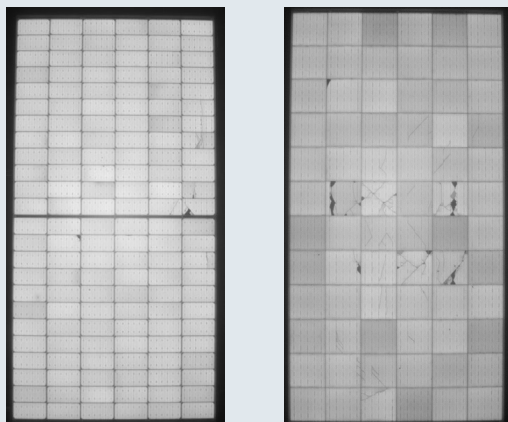
The EL images above compare a full cell module (right) and half-cell module (left) after MSS. The half-cell module shows very few cracks in comparison to the full cell module.

In some cases full cell modules are more susceptible to cell cracking than modules made with half-cut cells. This is likely because they have a larger cell surface area that needs to withstand the mechanical pressure during static mechanical load.

This is a nuanced finding, as cutting cells can actually create microcracks if done improperly.

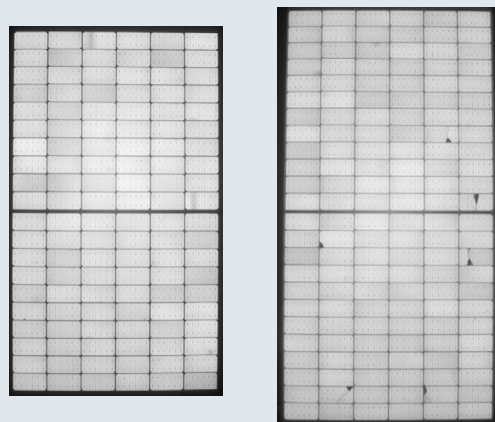
The PV modules pictured above have nearly identical BOMs. However, the 144-cell version of this BOM (right) proved more susceptible to microcracks than the 120-cell version (left).

The BOMs for the EL images pictured below are nearly identical – but one is a 144-cell design and the other is the same manufacturer’s 120-cell design.

While both performed relatively well, the 144-cell version experienced more cell cracks than the 120-cell version. **A larger surface area can result in more deflection during mechanical loading, which may generate cracks.**

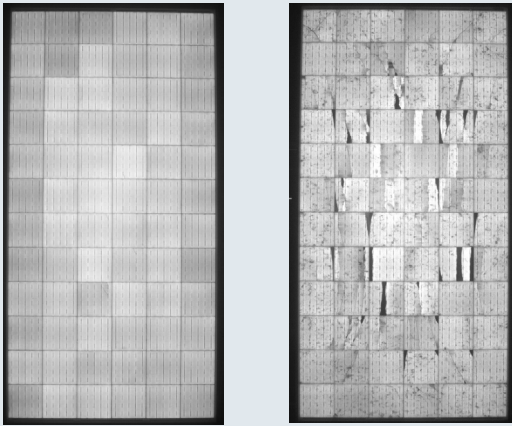
The multicrystalline PV module above (right) showed significant cell cracking and inactive areas following MSS, whereas the monocrystalline module (left) is unaffected.

The speed of the industry's transition from multicrystalline to monocrystalline silicon solar cells has surprised many analysts who foresaw that multicrystalline would have a larger market share than its current share of about ten percent. The obvious benefit of this transition is higher efficiency modules. PVEL's MSS test results point to another benefit: **multicrystalline cells are often more susceptible to cracks than monocrystalline cells.**

However, this observation comes with an important caveat: if monocrystalline modules are produced using substandard components or poor quality controls, they may be significantly more susceptible to cell cracking than is shown in the example below.

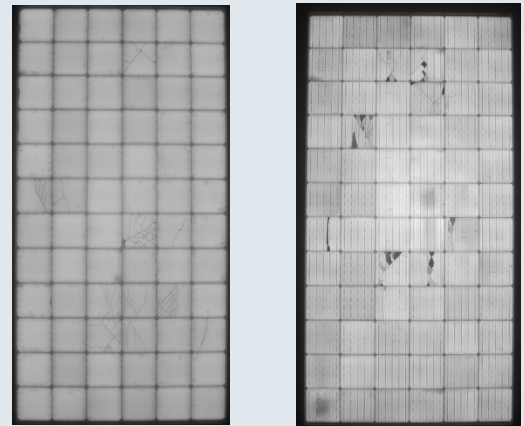
Both the 12 busbar (left) and five busbar (right) PV modules above suffered cracks during MSS testing, but the five busbar PV module has significantly more inactive areas.

Cell cracking can become a safety and performance issue when it creates inactive areas in the cells. PVEL has seen that there is a significant difference in inactive areas due to cell cracks for five busbar cells and 12 busbar cells.

In the five busbar example, the cell cracks have clearly created inactive zones where they have separated portions of the cells from the busbars. For the 12 busbar example, similar cell cracks have occurred, but due to the higher number of busbars spanning the cells, very few inactive areas can be seen.

While **resistance to power loss from cracking is an innate advantage for multi-busbar modules**, it is important to note that there are five and six busbar modules that have performed well in PVEL's MSS testing.

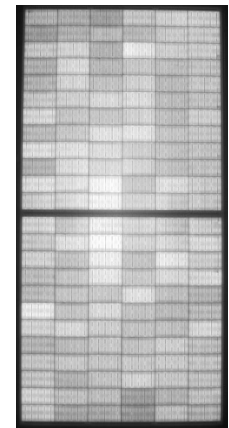
PVEL has observed strong results from glass//glass modules. The module below shows no cracking post-MSS.
