PV Module Product Qualification Program (PQP): Backsheet Durability Sequence

PVEL's Backsheet Durability Sequence (BDS)

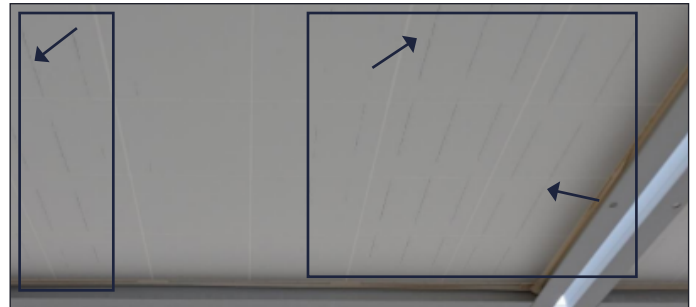
Backsheet cracks that allow moisture to enter a PV module can severely impact field performance. Other signs of backsheet aging, such as yellowing and chalking (this refers to powder accumulation on the backsheet as the material breaks down), are often signs of accelerating backsheet degradation.

Backsheet failure in the field
