Back-Contact cell technology
*A first attempt at benchmarking the
reliability and performance of BC modules*

Jean-Nicolas JAUBERT
Director of China Operations
Kiwa PVEL

11/22/2024, Zhuhai BiFi Workshop

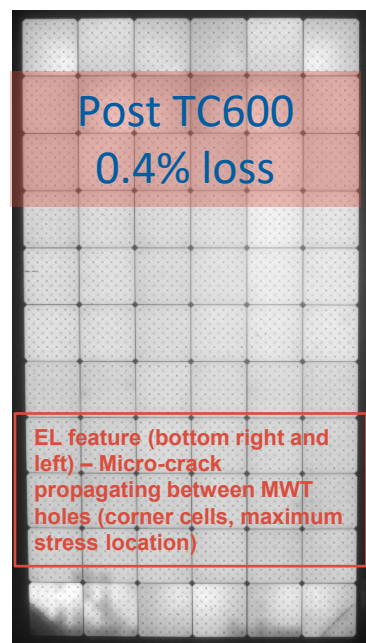
Thermal Cycling Failure Modes – xBC specific examples

Failure Mode	Description	xBC specific?	Observed in PQP
Cell-interconnect solder fracture	Improper stress relieve design (adjacent cells or adjacent solder pads)	Yes	Yes

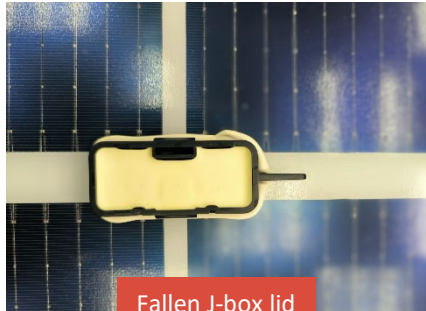
Fallen J-box lid

Junction box or connector swelling		No	Yes

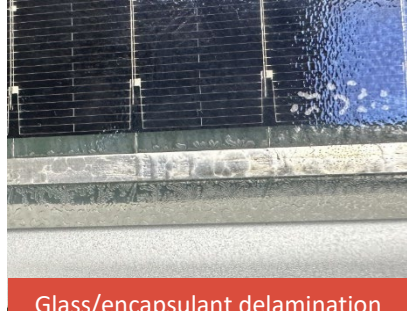
Glass/encapsulant delamination

Failure Mode	Description	xBC specific?	Observed in PQP
Cell metallization corrosion (fingers)	Reaction of lead oxide with acetic acid from encapsulant, usually happening at the cell edge, led to disconnection of fingers from Si	Possibly	Yes
Cell metallization corrosion (busbars)	Chemical of galvanic corrosion of fingers and busbars connection	No	Yes
Delamination	Material compatibility or process issue, continuous bubbles path leading to sub-standard creepage distances	No	Yes
Encapsulation material yellowing	Material incompatibility or encapsulation recipe (instable additives)	No	Yes
Glass ARC coating degradation	Damages of glass ARC due to moisture	No	Yes
Loss of cell passivation (thermal activation of defect centers)	Increase in front or rear surface recombination under temperature stress, various mechanisms (i.e. LID, LETID...)	No	Yes
Backsheet bubbles and cracking	Degradation of mechanical properties (i.e. adhesion intra-layers)	No	Yes

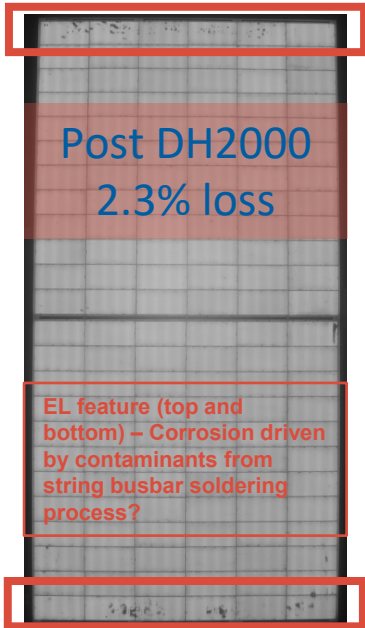
Damp Heat Failure Modes – xBC specific examples

■ Three common corrosion signatures observed post-DH for front contact cell designs:

1. Corrosion of cell fingerprints.
2. Electro-chemical corrosion of finger/busbars connections.
3. Contaminants-driven corrosion mechanisms (Na+).

■ Expect the same corrosion modes possible for xBC cells depending on topology, observed modes 2&3 in past projects, to lesser extent.

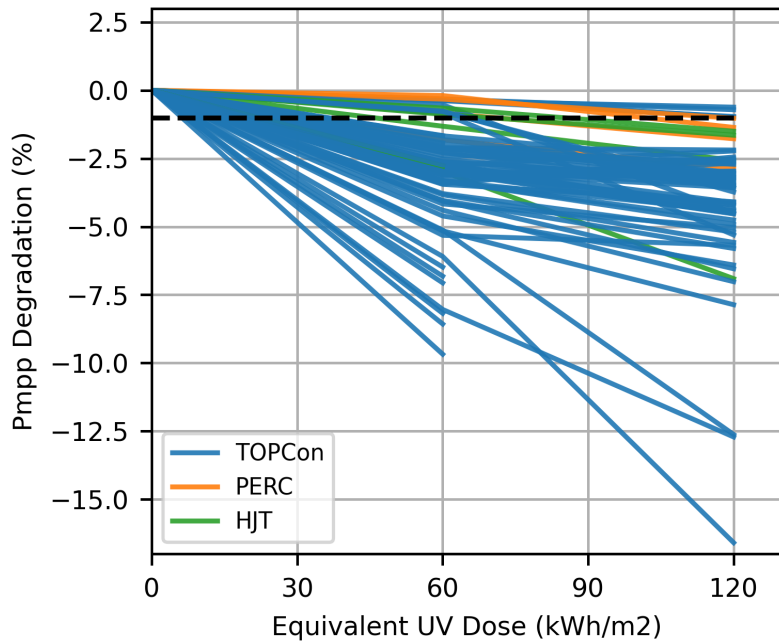
UV 60 kWh/m²
60°C front

Characterization
